PPH Investigation and Sanitary Sewer Study

Prepared for: City of Glendale, WI

Project Number: G0580190

Prepared by: Clark Dietz, Inc.
Date: March 2021

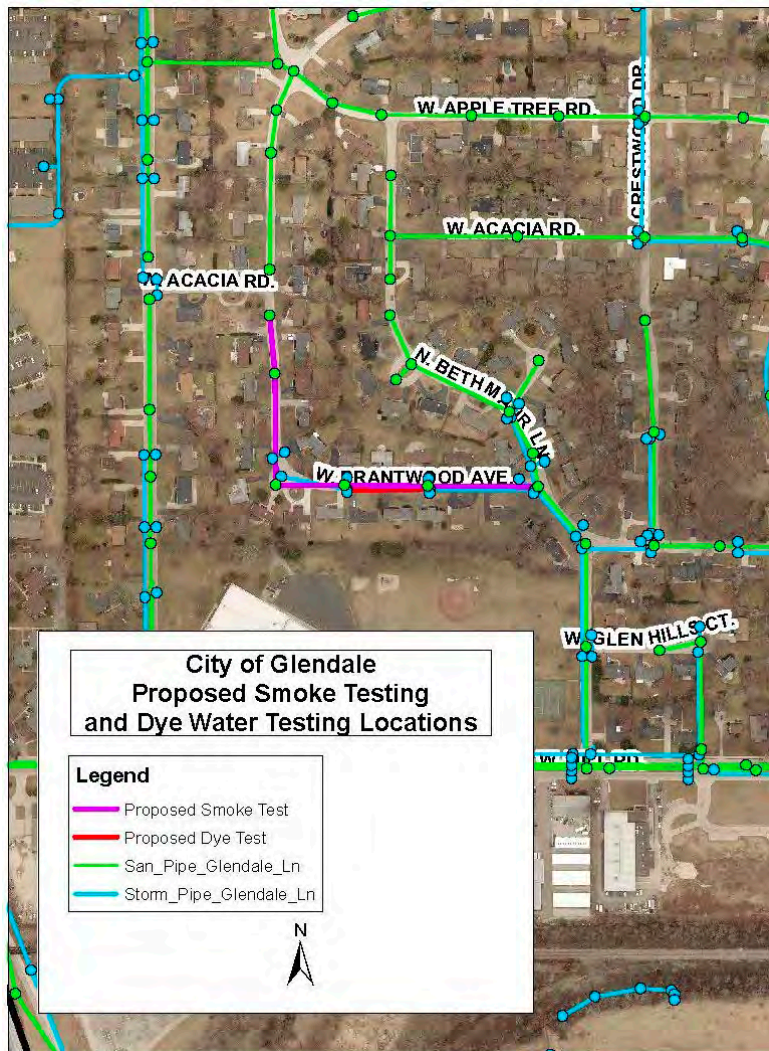
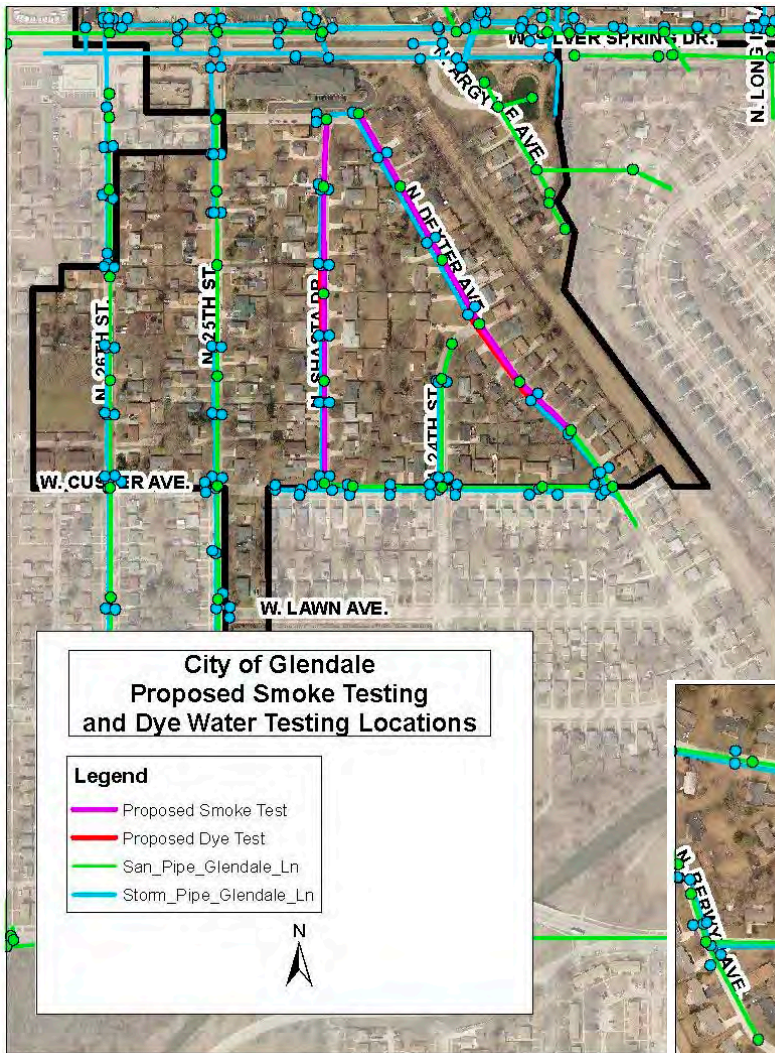
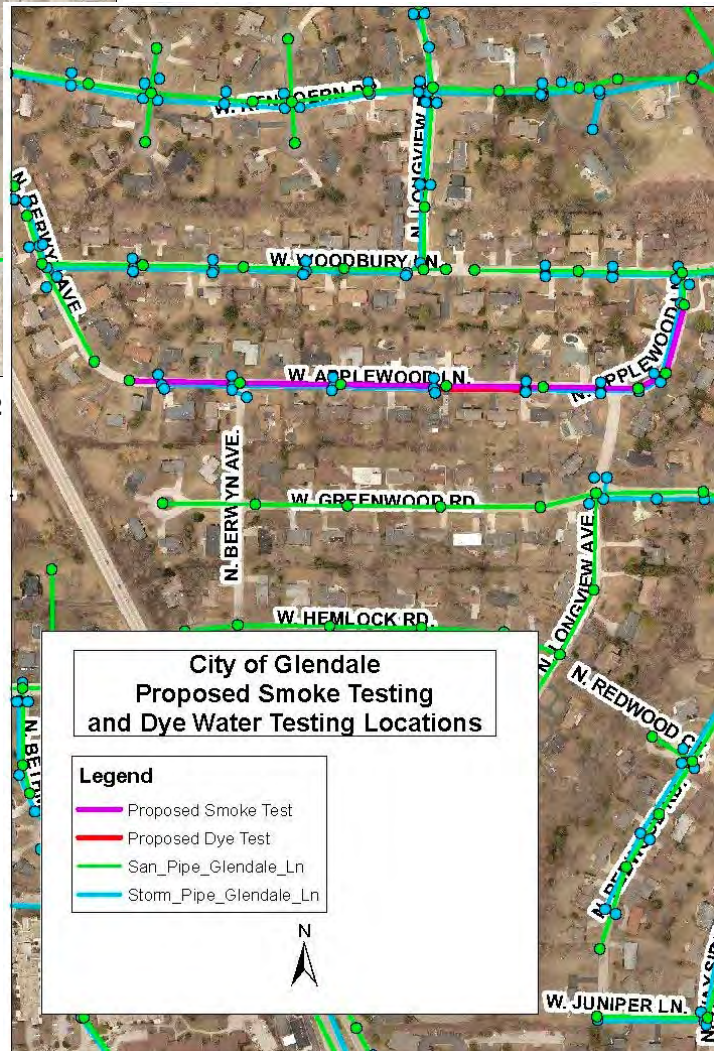
In 2020, Glendale implemented a pilot program to complete field investigation of their sanitary sewer system. The field work included dye water flooding of storm sewers at four roadway and storm sewer segments in the City as identified by the wet weather peak flows identified for each sewershed. Glendale performed smoke testing along approximately 22 sewer segments throughout the City. The locations of the testing performed are found in Figure 3.8 - 3.10.

Glendale performed smoke testing along approximately 22 sewer segments throughout the City in three different sewersheds. Some of the major results that the test identified were cross infiltration from the storm sewer and sanitary sewer along Applewood Ln. This was indicated by two smoking storm inlets. A cracked lateral at 5465 N. Dexter Ave was also discovered which is causing infiltration into the system. It also revealed that 6529 W Brentwood Ave. has a connected sump pump causing inflow into the sanitary collection system.

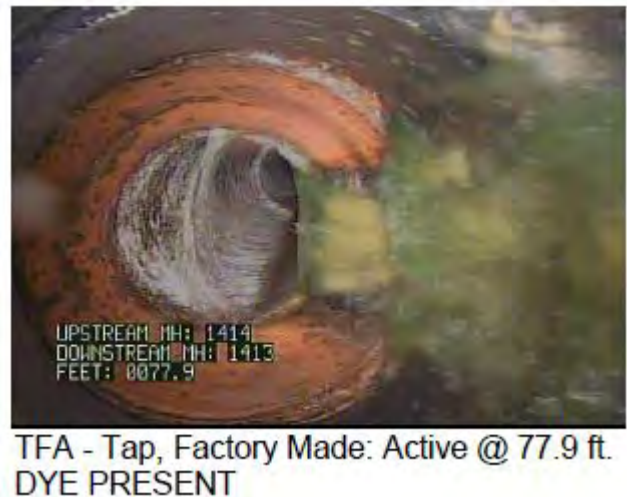
The test revealed five private laterals that showed dye transference from the storm sewer indicating infiltration from the storm sewer into the sanitary sewer. The locations were 2415 W. Brantwood Ave, 2145 N. Applewood Ln, 2125 N. Applewood Ln, 2115 N. Applewood Ln, and 2140 N. Applewood Ln. The amount of flow being infiltrated from these 5 laterals was substantial. See Figure 3.11 showing an image captured during the test identifying exactly which lateral is causing infiltration. The full dye water test report can be found in Appendix D.

Figure 3.11 Private Property Lateral showing I/I from Dye Water Test

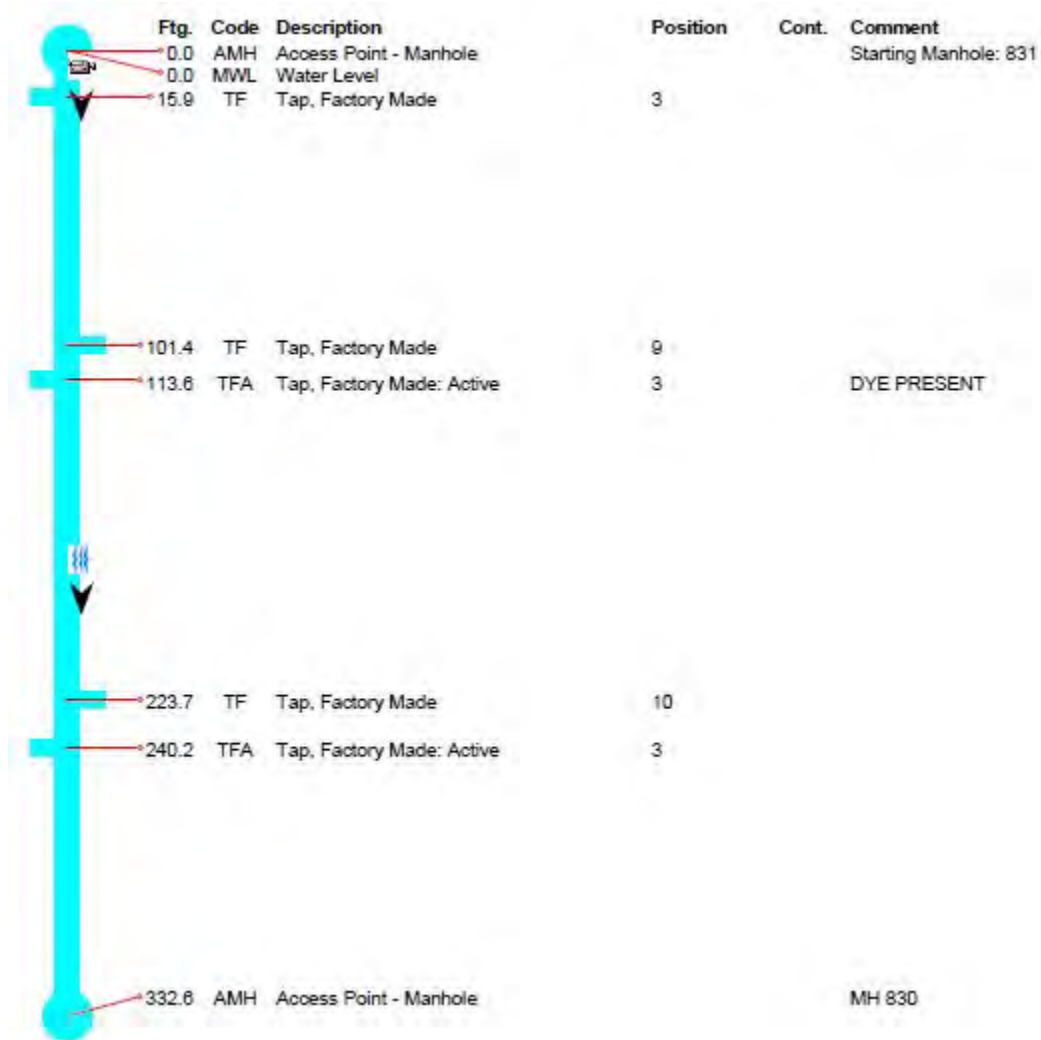
The 2020 pilot test identified the following properties having large sources of infiltration.

- 2125 N. Applewood Ln. (dye transfer)
- 2115 N. Applewood Ln. (dye transfer)
- 2140 N. Applewood Ln. (dye transfer)
- 5465 N. Dexter Ave. (smoke seen)

Figure 5.7 Summary Example of Private Laterals with Dye Present during Field Investigation

These properties should be included on the list created of homeowners to be approached to participate in private property inflow and infiltration programs.
