PPH Investigation and Sanitary Sewer Study

Prepared for: City of Glendale, WI

Project Number: G0580190

Prepared by: Clark Dietz, Inc.
Date: March 2021

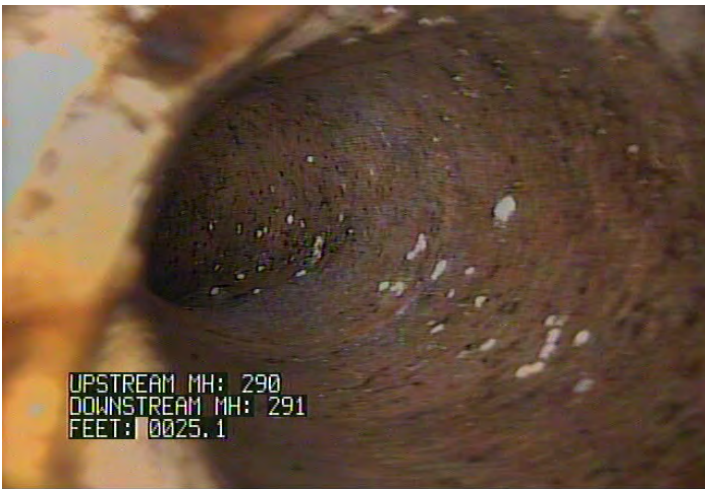
TF - Tap, Factory Made @ 25.1 ft. T
LINER (CIPP)

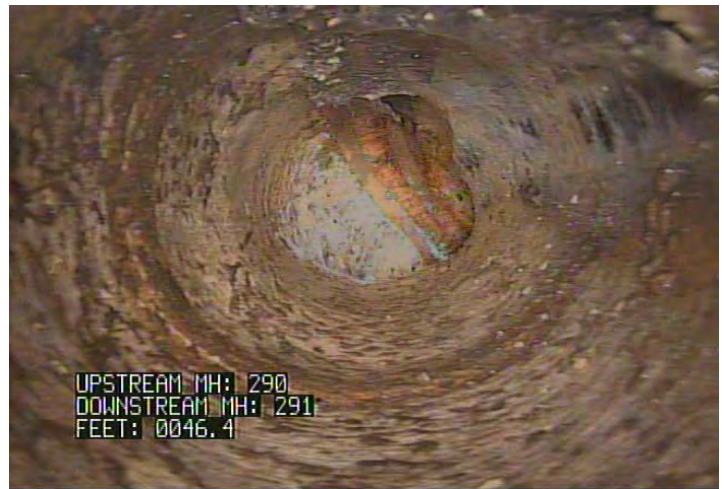
TF - Tap, Factory Made @ 46.4 ft. T
LINER (CIPP)

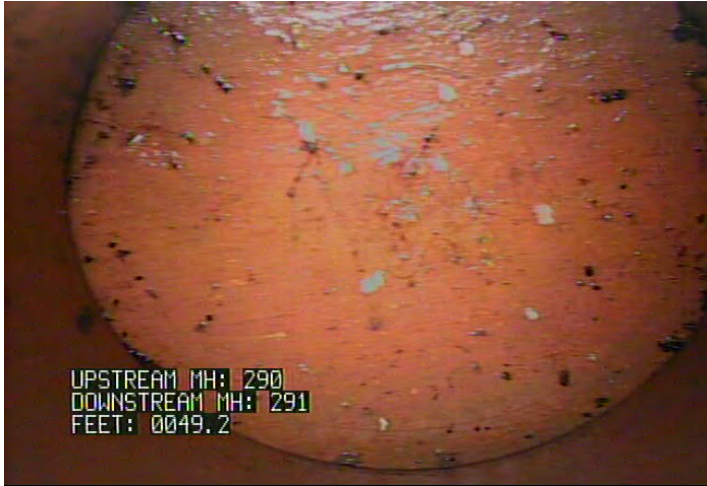
TFC - Tap, Factory Made: Capped @ 49.2 ft.

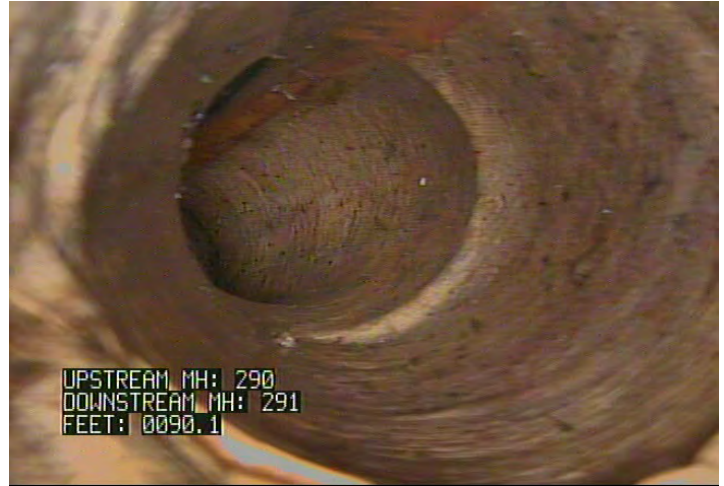
TF - Tap, Factory Made @ 90.1 ft. T LINER (CIPP)

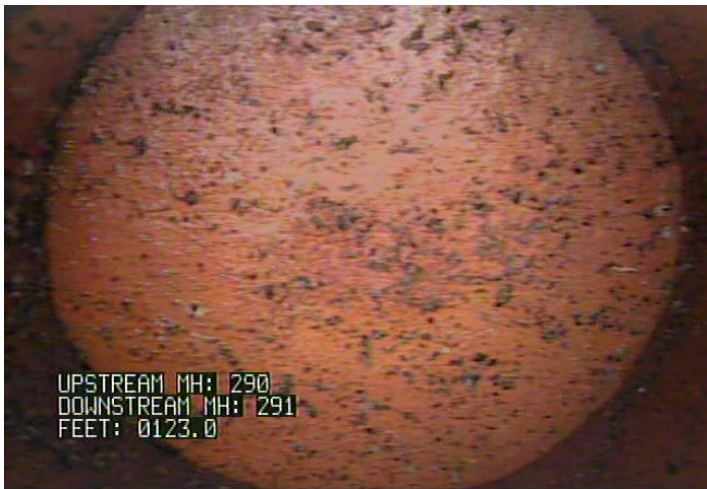
TFC - Tap, Factory Made: Capped @ 123.0 ft.

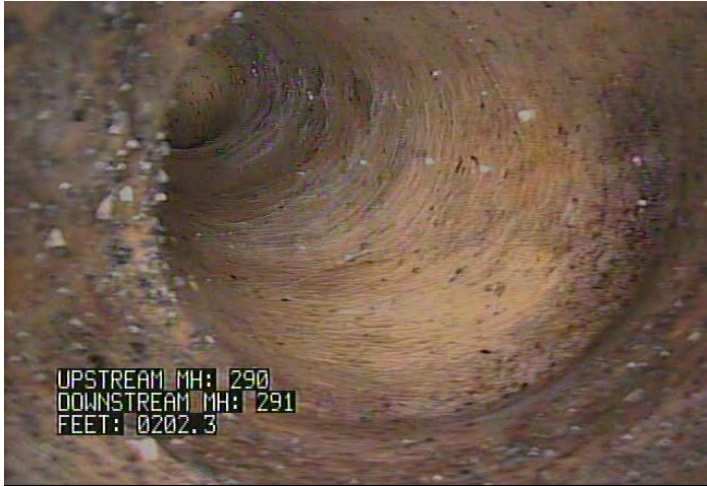
TF - Tap, Factory Made @ 202.3 ft. T
 LINER (CIPP)

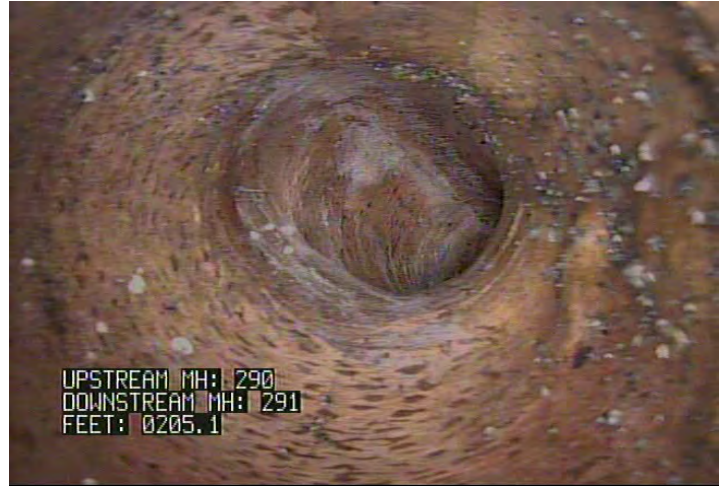
TF - Tap, Factory Made @ 205.1 ft. T
 LINER (CIPP)

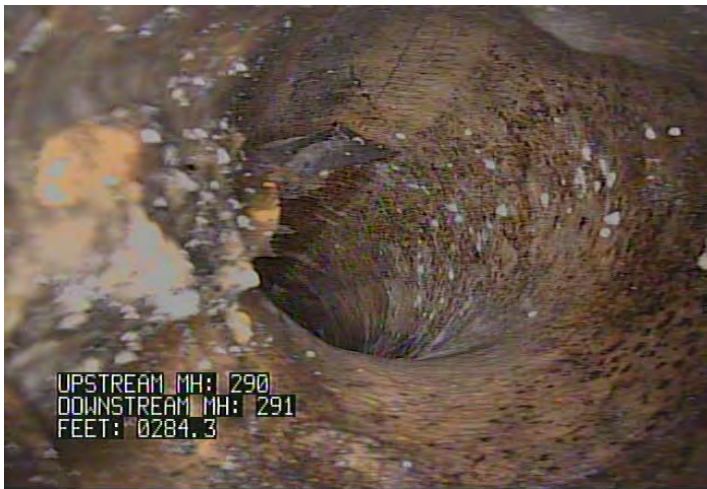
TF - Tap, Factory Made @ 284.3 ft. T
 LINER (CIPP)

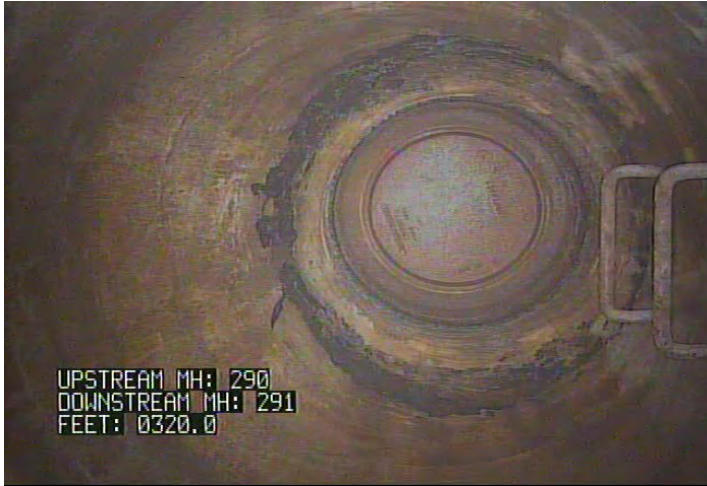
AMH - Access Point - Manhole @ 320.0 ft.
MH 291

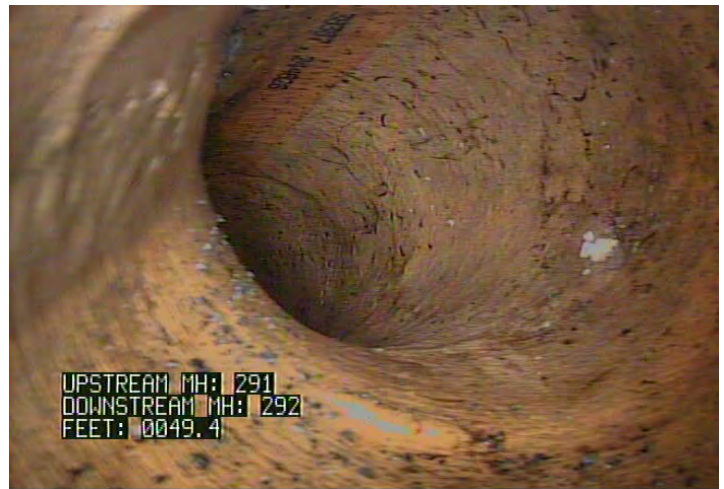
TF - Tap, Factory Made @ 49.4 ft. T
LINER (CIPP)

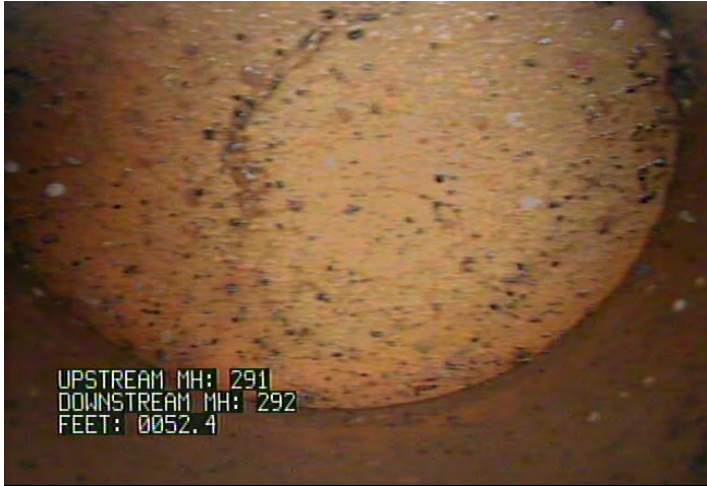
TFC - Tap, Factory Made: Capped @ 52.4 ft.

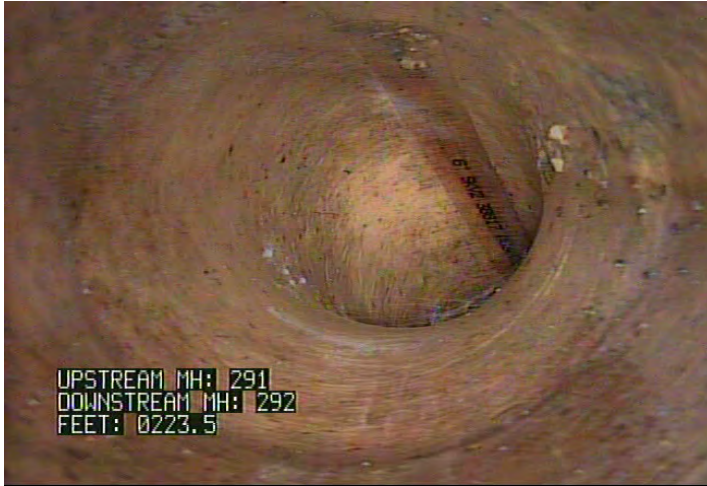
TF - Tap, Factory Made @ 223.5 ft. T LINER (CIPP)

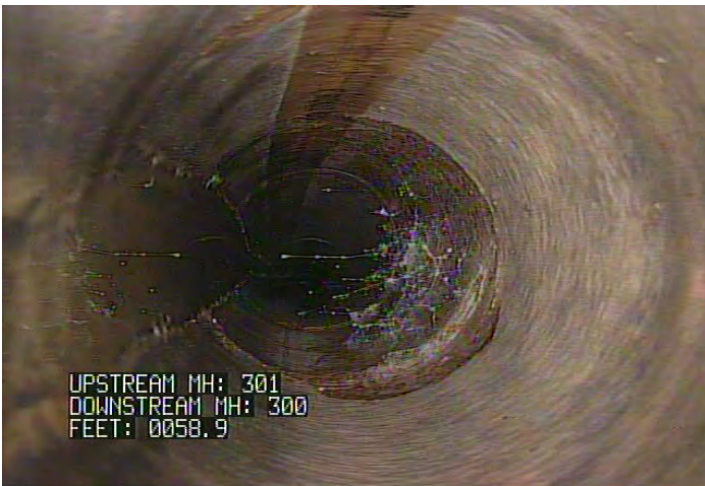
TF - Tap, Factory Made @ 58.9 ft. T
LINER (CIPP)

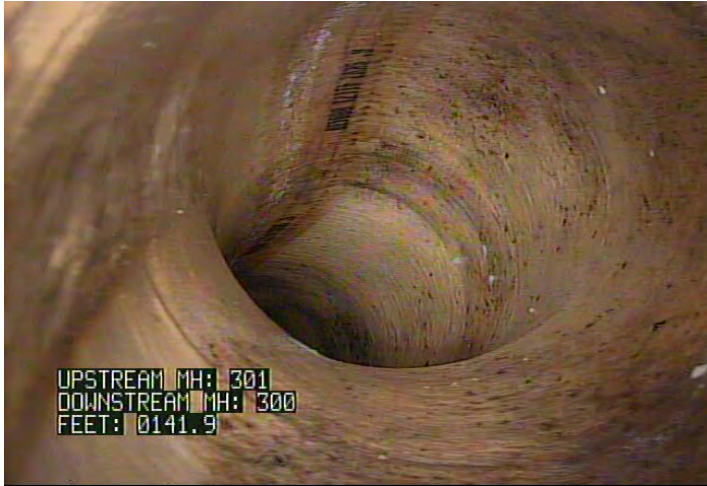
TF - Tap, Factory Made @ 141.9 ft. T LINER (CIPP)

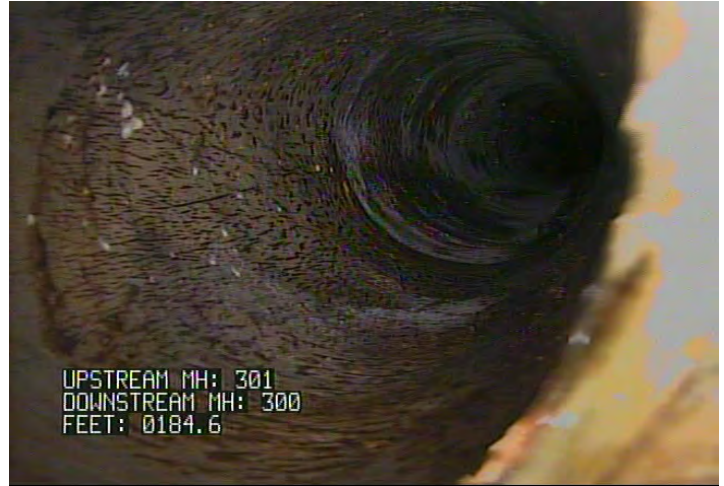
TF - Tap, Factory Made @ 184.6 ft. T LINER (CIPP)

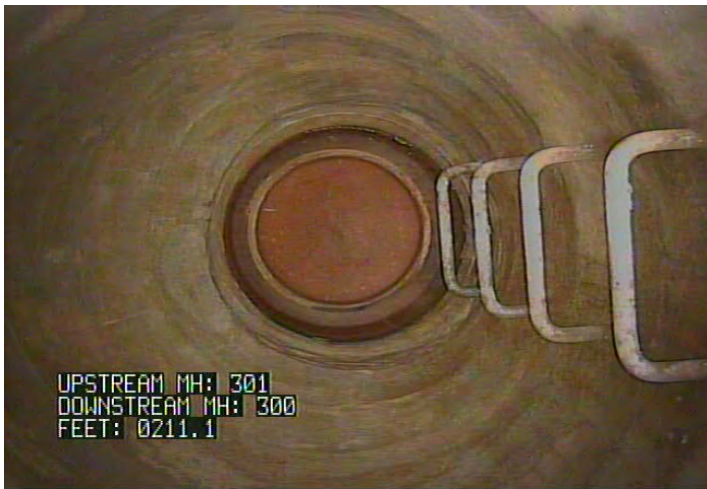
AMH - Access Point - Manhole @ 211.1 ft. MH 300

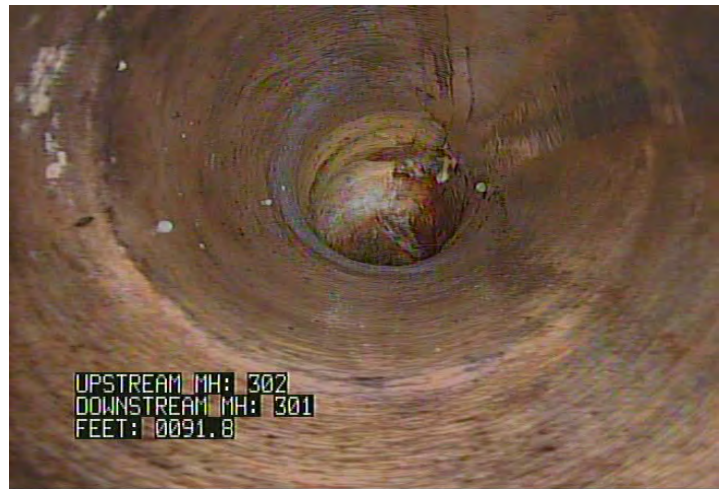
TF - Tap, Factory Made @ 91.8 ft. T
 LINER (CIPP)

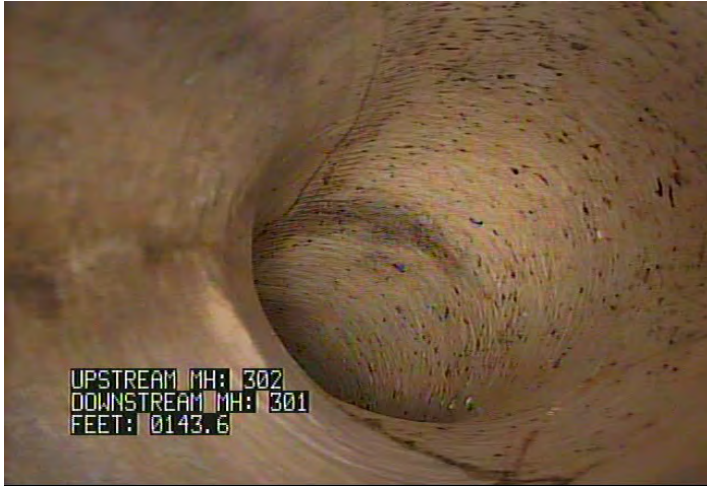
TF - Tap, Factory Made @ 143.6 ft. T LINER (CIPP)

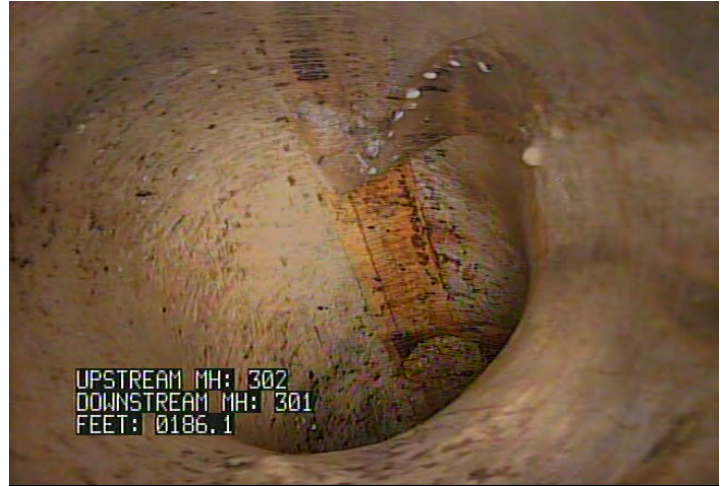
TF - Tap, Factory Made @ 186.1 ft. T LINER (CIPP)

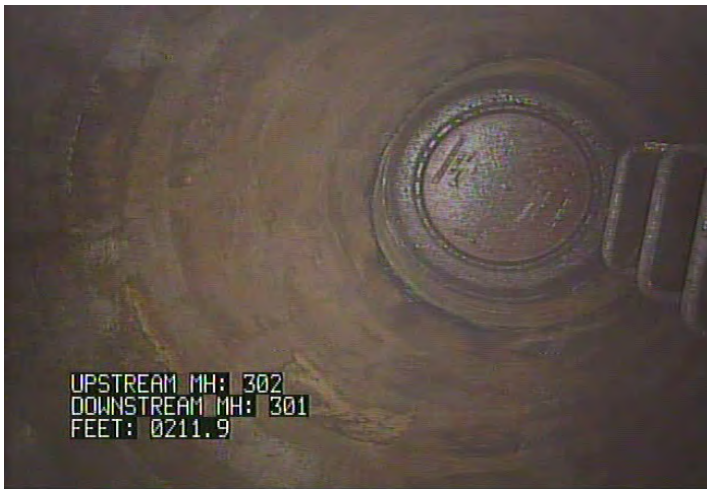
AMH - Access Point - Manhole @ 211.9 ft. MH 301

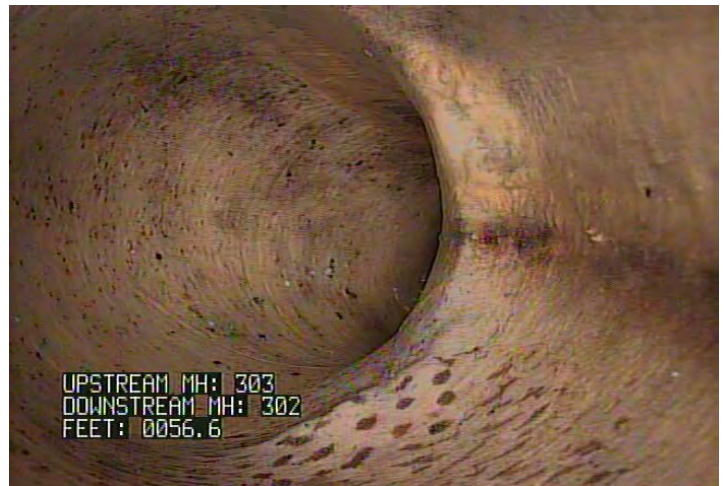
TF - Tap, Factory Made @ 56.6 ft. (CIPP)
 T LINER

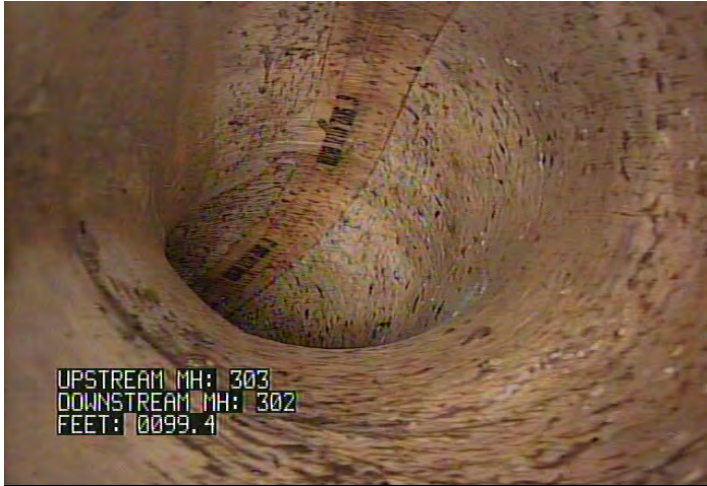
TF - Tap, Factory Made @ 99.4 ft. T LINER (CIPP)

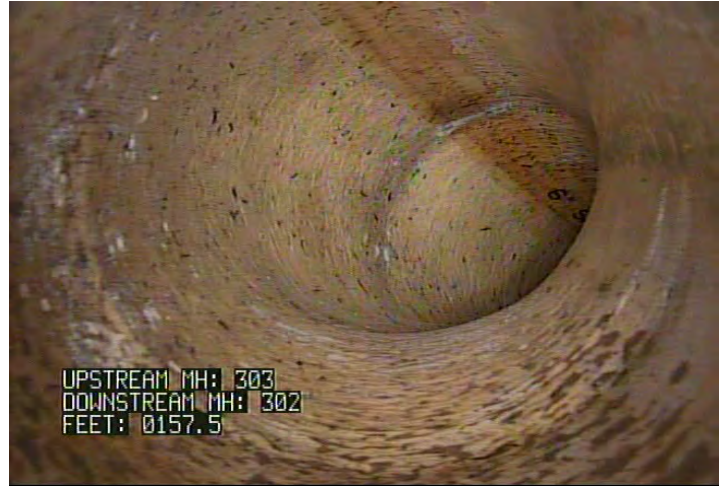
TF - Tap, Factory Made @ 157.5 ft. T LINER (CIPP)

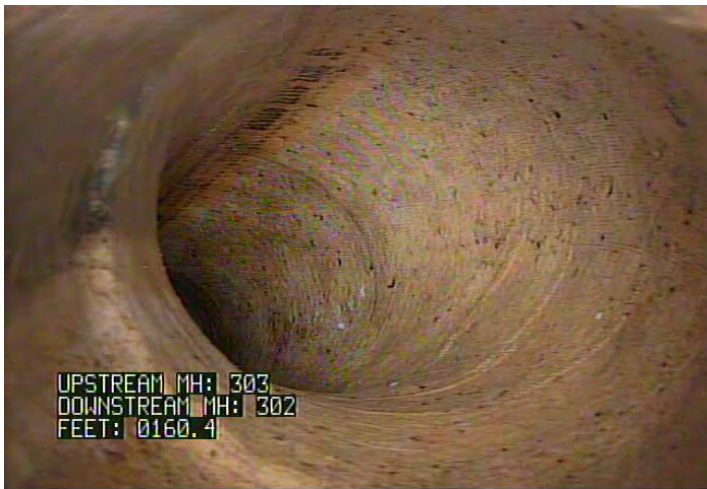
TF - Tap, Factory Made @ 160.4 ft. T LINER (CIPP)

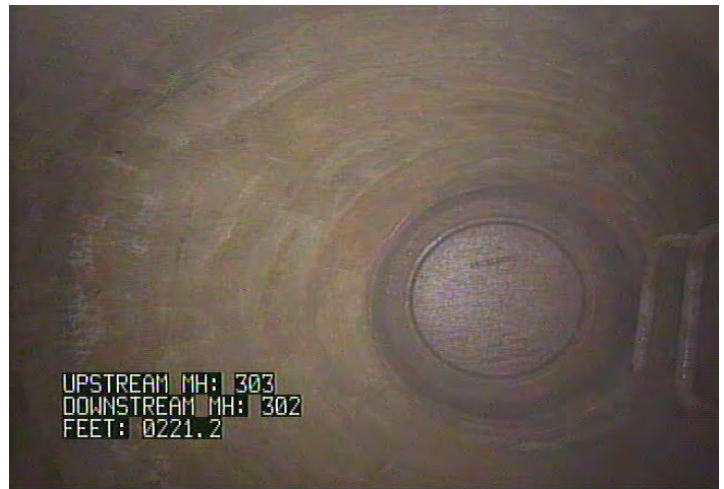
AMH - Access Point - Manhole @ 221.2 ft. MH 302

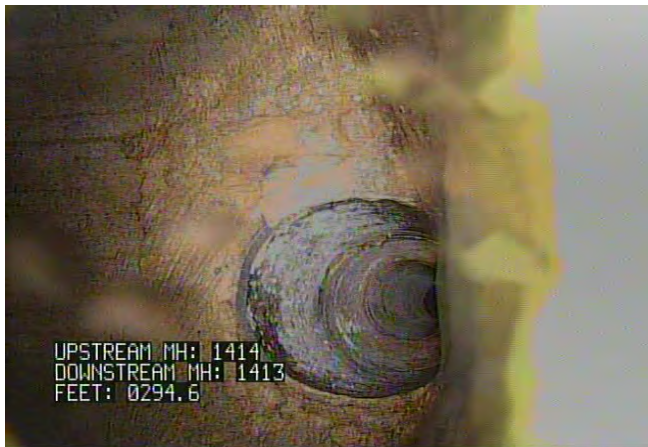
TFA - Tap, Factory Made: Active @ 294.6 ft. LATERAL INSIDE THE MH (DYE PRESENT)
