PPH Investigation and Sanitary Sewer Study

Prepared for: City of Glendale, WI

Project Number: G0580190

Prepared by: Clark Dietz, Inc.
Date: March 2021

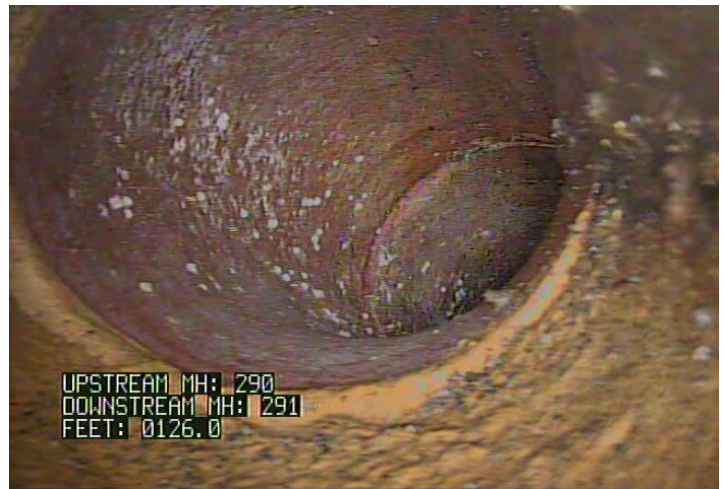
TF - Tap, Factory Made @ 126.0 ft.

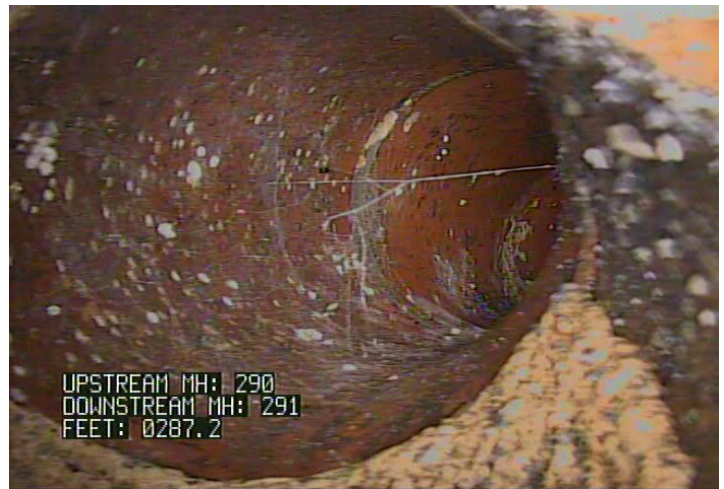
TF - Tap, Factory Made @ 287.2 ft.

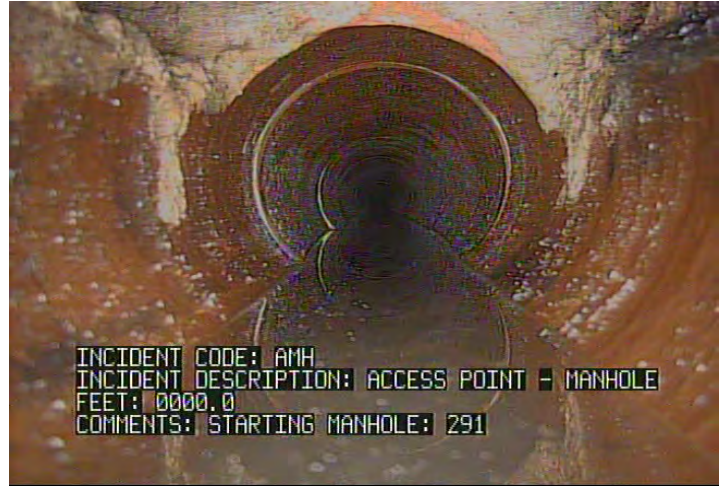
AMH - Access Point - Manhole @ 0.0 ft.
Starting Manhole: 291

MWL - Water Level @ 0.0 ft.

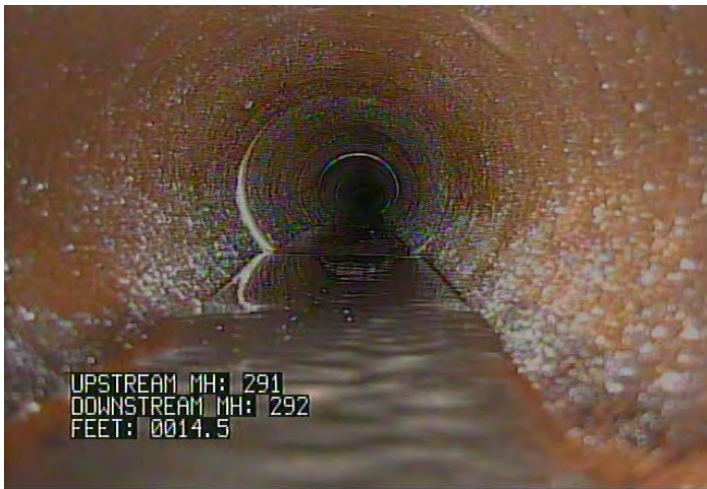
DSGV - Deposits Settled: Gravel @ 14.5 ft.

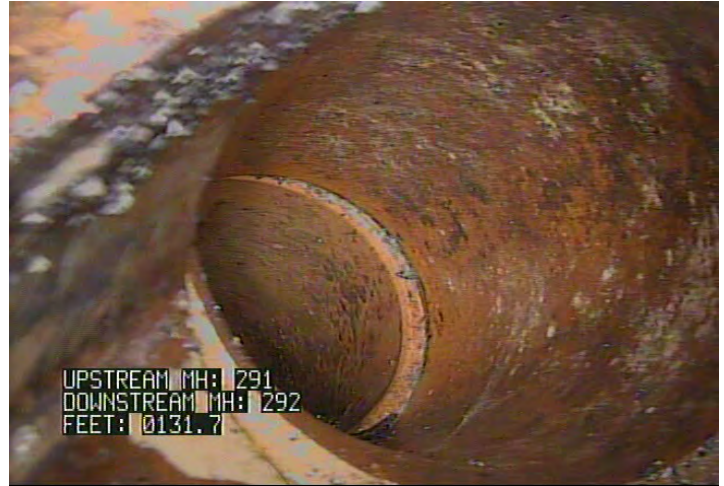
TFA - Tap, Factory Made: Active @ 131.7 ft.

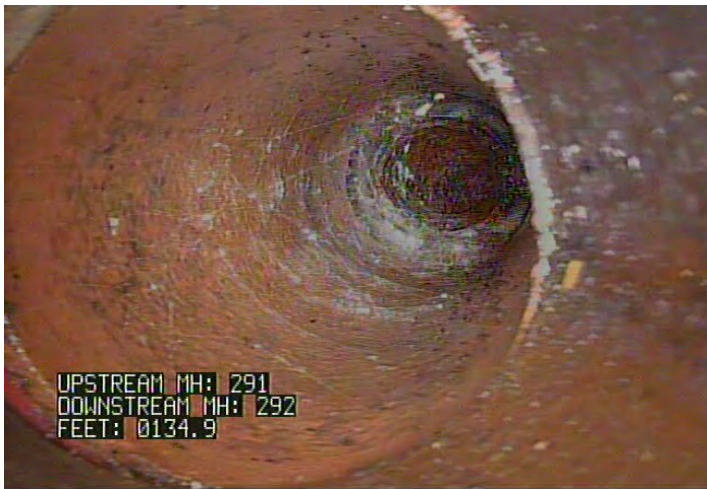
TF - Tap, Factory Made @ 134.9 ft.

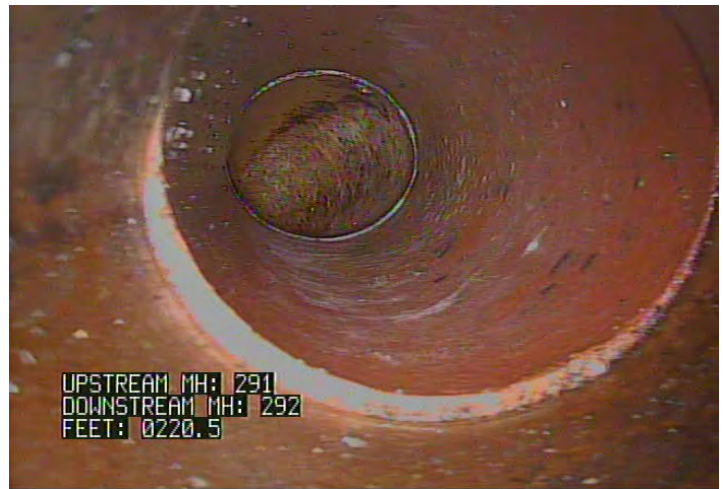
TF - Tap, Factory Made @ 220.5 ft.

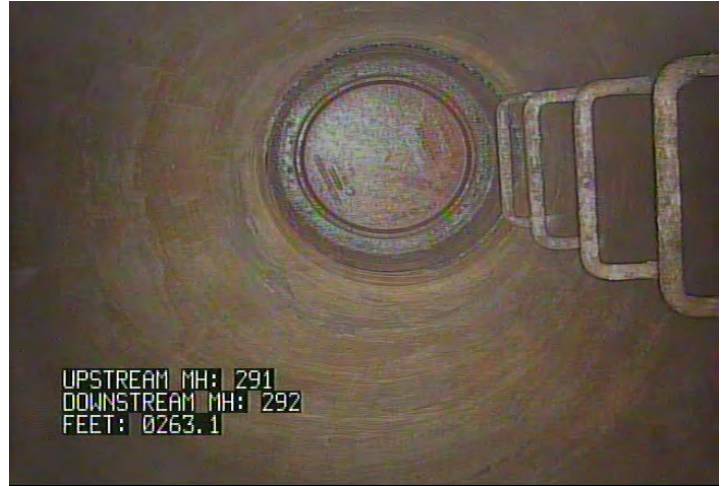
DSGV - Deposits Settled: Gravel @ 263.1 ft.

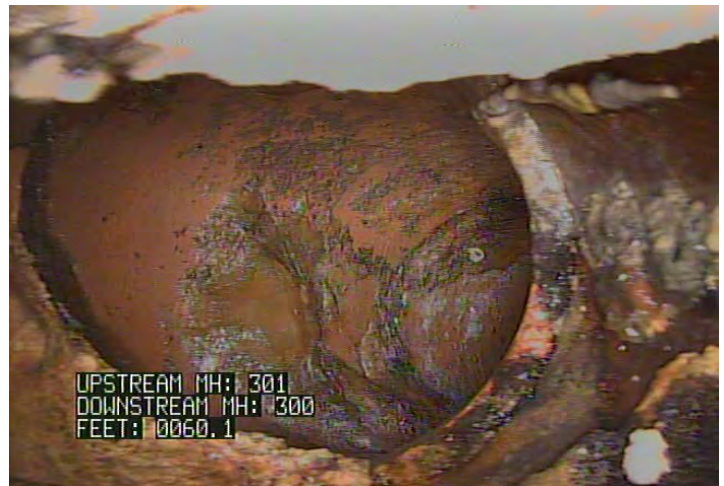
TFA - Tap, Factory Made: Active @ 60.1 ft.

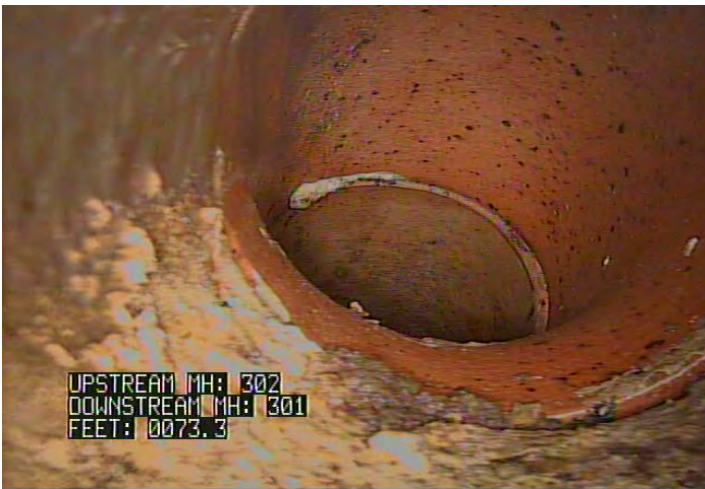
TF - Tap, Factory Made @ 73.3 ft.

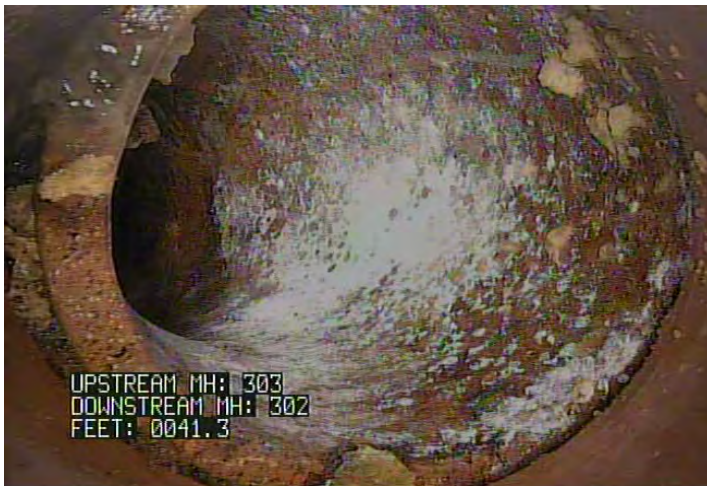
TFA - Tap, Factory Made: Active @ 41.3 ft.

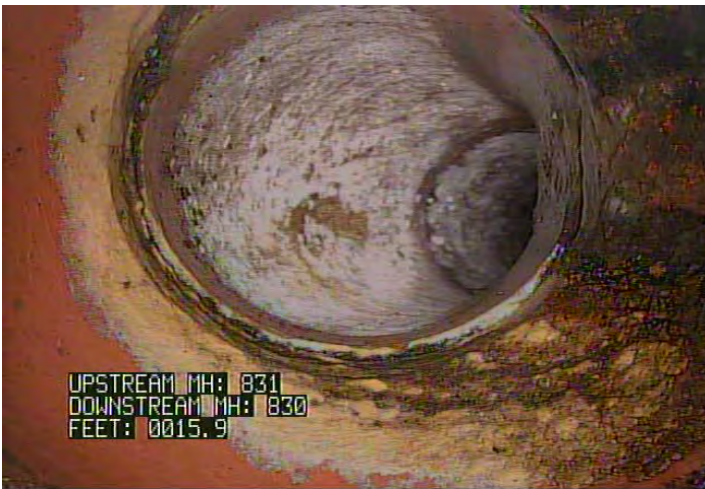
TF - Tap, Factory Made @ 15.9 ft.

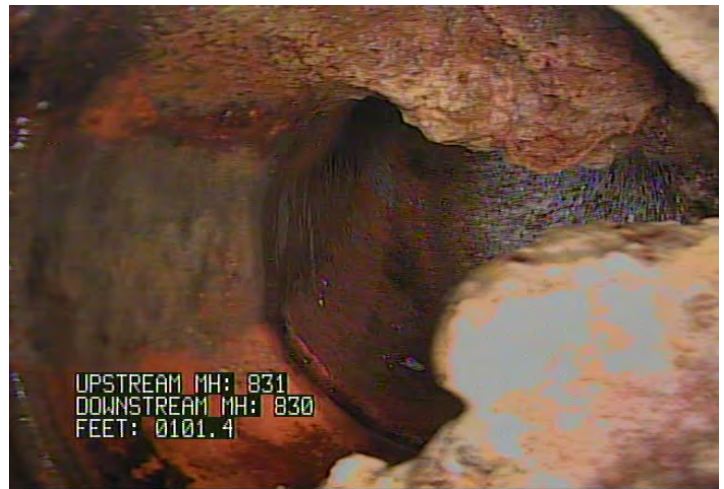
TF - Tap, Factory Made @ 101.4 ft.

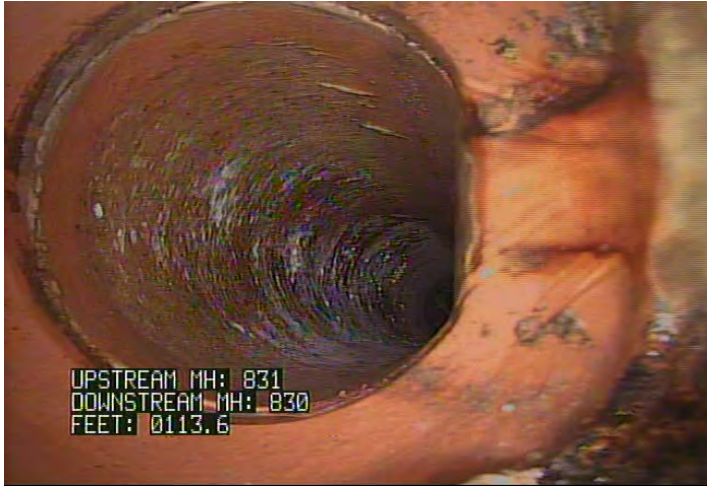
TFA - Tap, Factory Made: Active @ 113.6 ft. DYE PRESENT

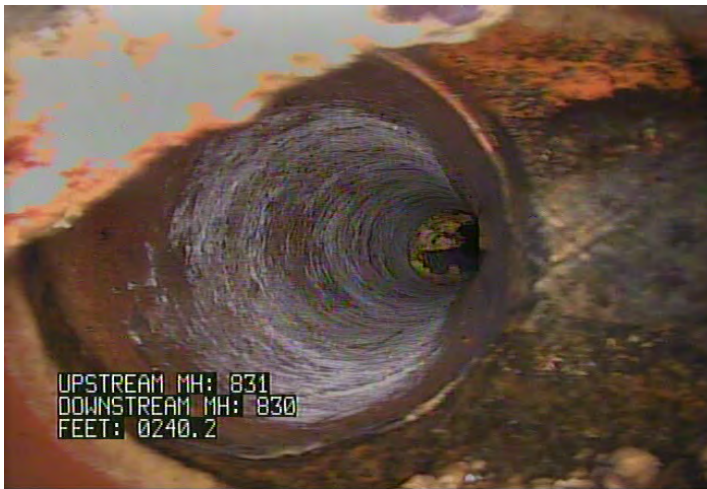
TFA - Tap, Factory Made: Active @ 240.2 ft.

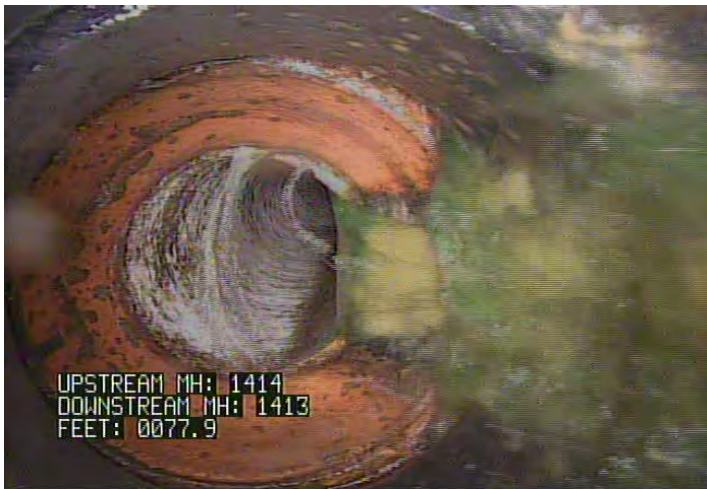
TFA - Tap, Factory Made: Active @ 77.9 ft.
DYE PRESENT

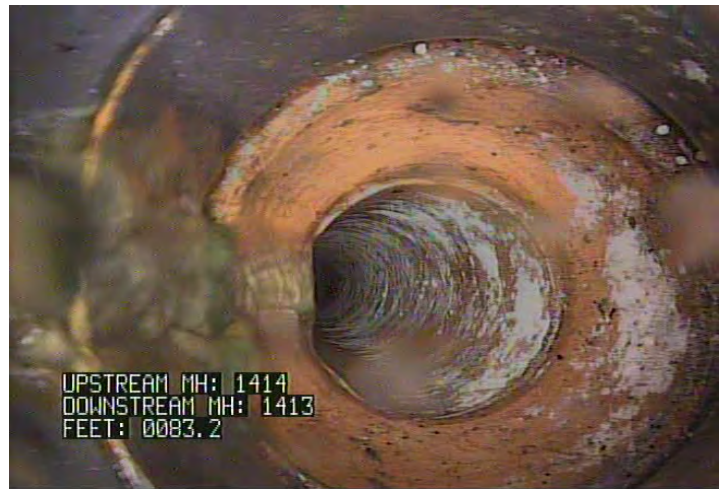
TFA - Tap, Factory Made: Active @ 83.2 ft.
DYE PRESENT

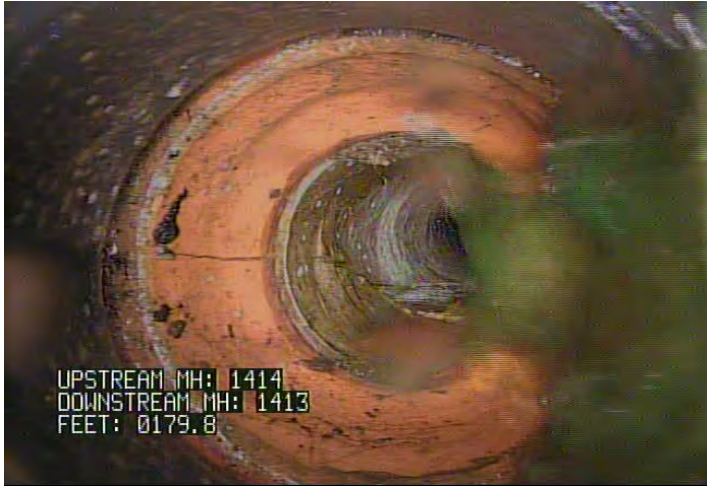
TFA - Tap, Factory Made: Active @ 179.8 ft. DYE PRESENT

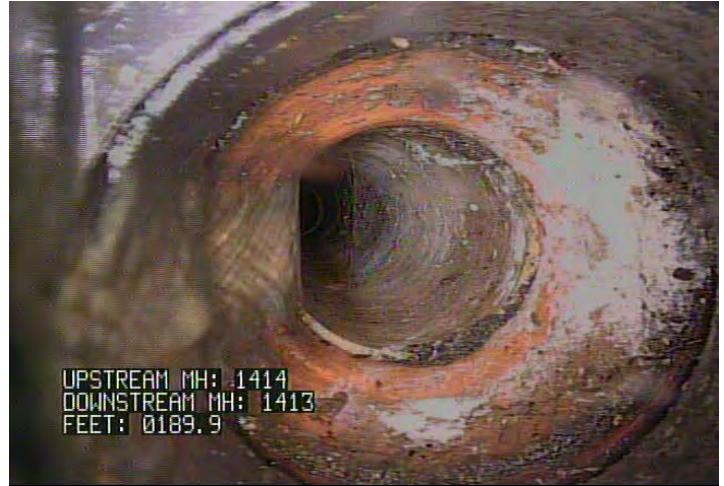
TFA - Tap, Factory Made: Active @ 189.9 ft.

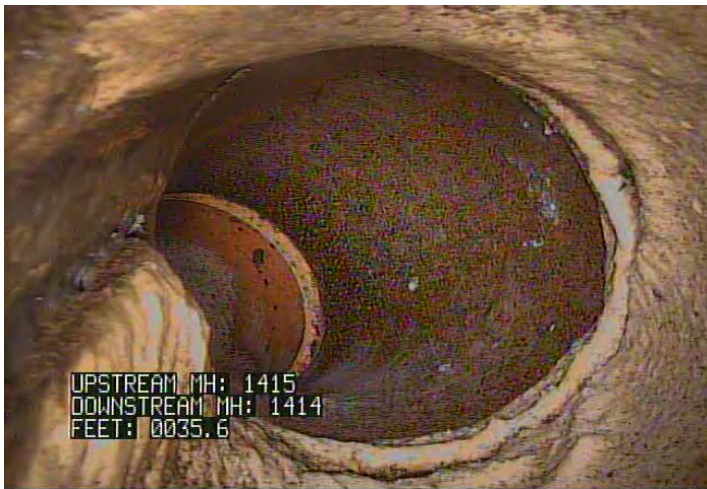
UPSTREAM MH: 1415
 DOWNSTREAM MH: 1414
 FEET: 0035.6

TF - Tap, Factory Made @ 35.6 ft.

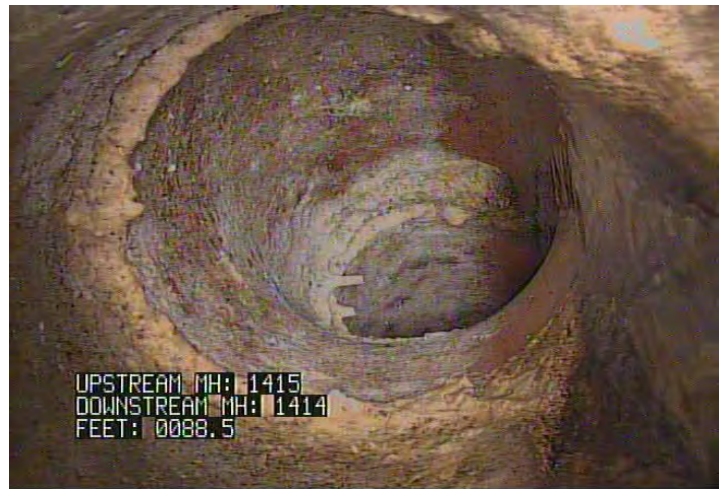
UPSTREAM MH: 1415
 DOWNSTREAM MH: 1414
 FEET: 0088.5

TFA - Tap, Factory Made: Active @ 88.5 ft.

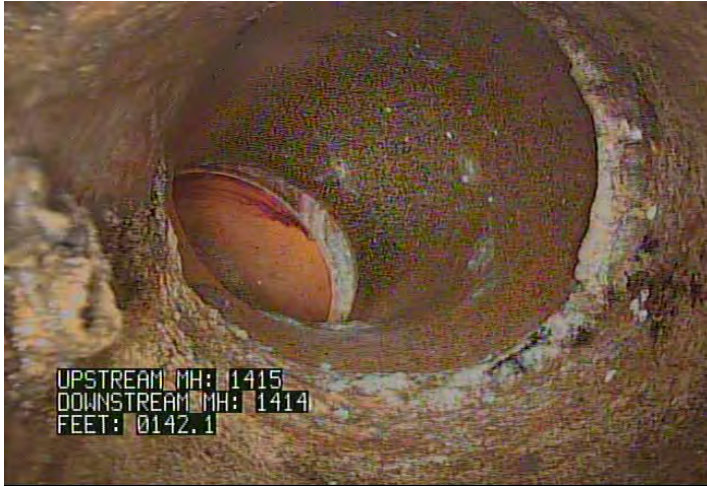
TF - Tap, Factory Made @ 142.1 ft.

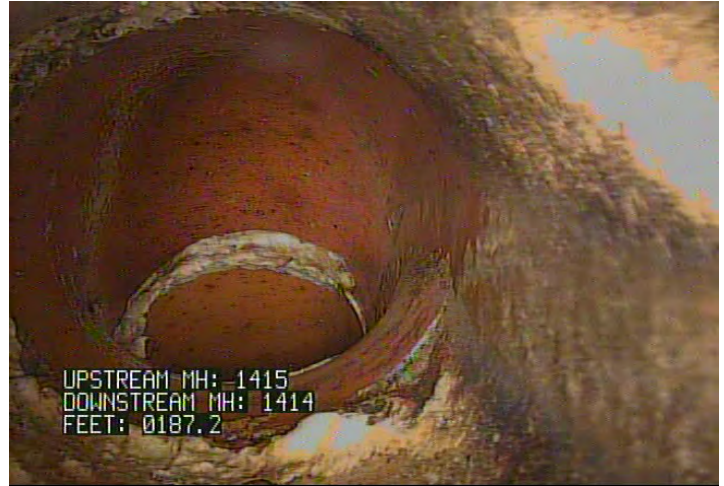
TF - Tap, Factory Made @ 187.2 ft.

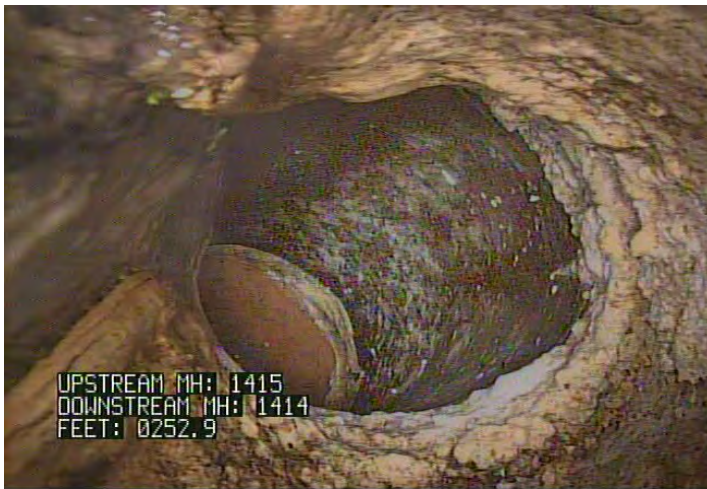
TFA - Tap, Factory Made: Active @ 252.9 ft.

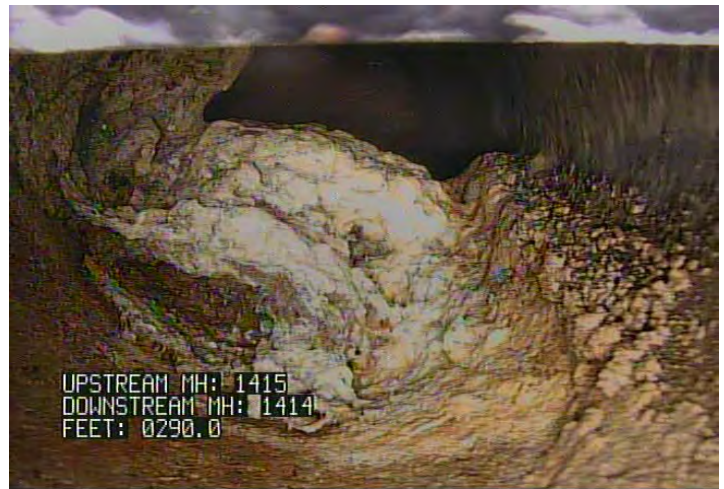
TF - Tap, Factory Made @ 290.0 ft.

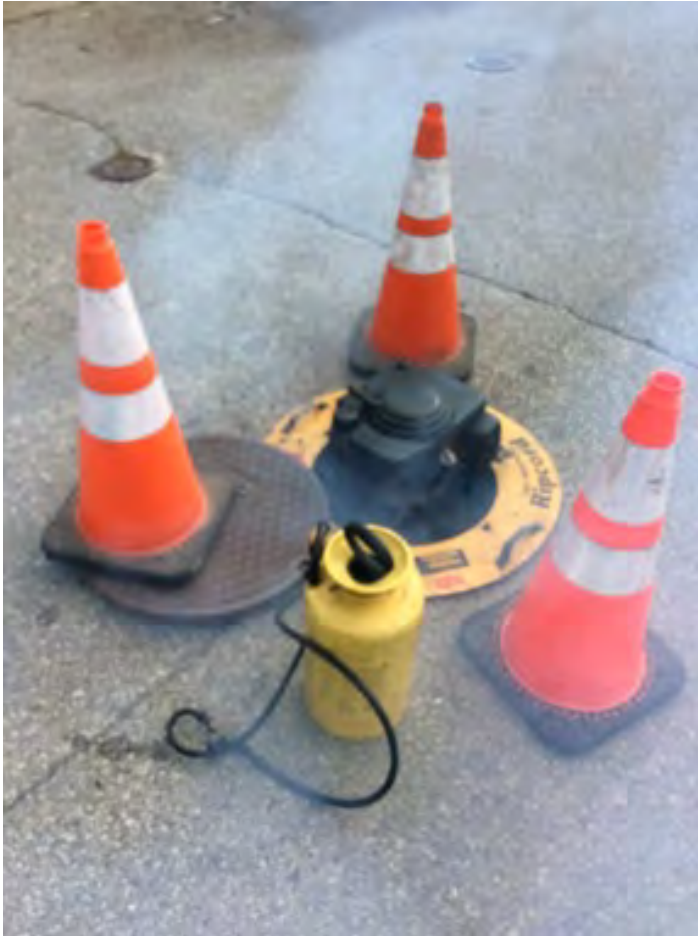
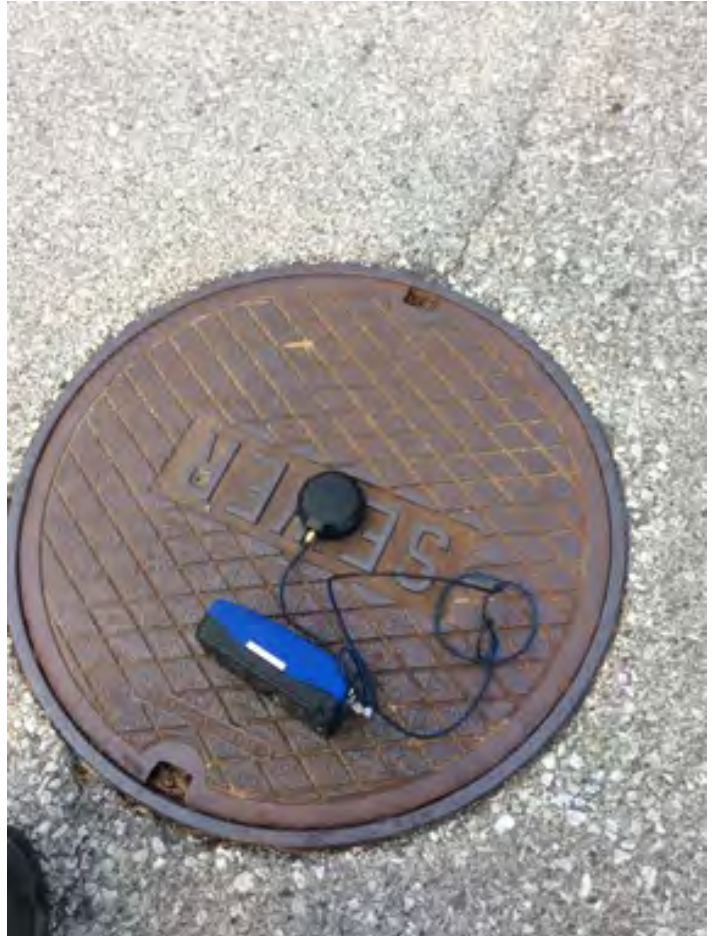
Observations / 1

Smoke Quality: SQG - Good	Defect Type: MFC - Manhole Frame/Cover
Defect Location: AMH - Manhole	
Defect Address: 290	Inflow Potential: IX - None Likely
Distance from Upstream Manhole:	Surface Cover: ST - Street
Surface Material Paved: true	Geolocation: 43.11790501666666 E -87.94263463333333 N
Comments:

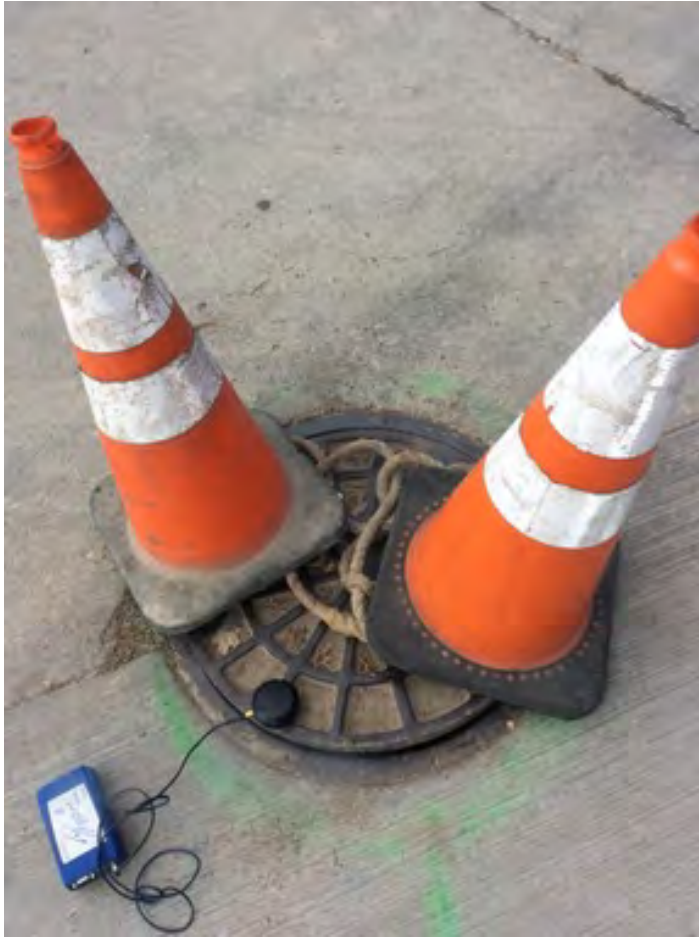
Observations / 2

Smoke Quality: SQG - Good	Defect Type: MFC - Manhole Frame/Cover
Defect Location: AMH - Manhole	
Defect Address: 293	Inflow Potential: IN - None
Distance from Upstream Manhole:	Surface Cover: ST - Street
Surface Material Paved: true	Geolocation: 43.11548586333333 E -87.94270015 N
Comments:
